# Artesis AMT

## Condition Assessment Cases

This document presents fault detection and diagnosis examples of AMT for various equipment in various industries. Examples of fault comparison between two identical equipment, before-after maintenance measurements and basic PSD curve analyses are given.

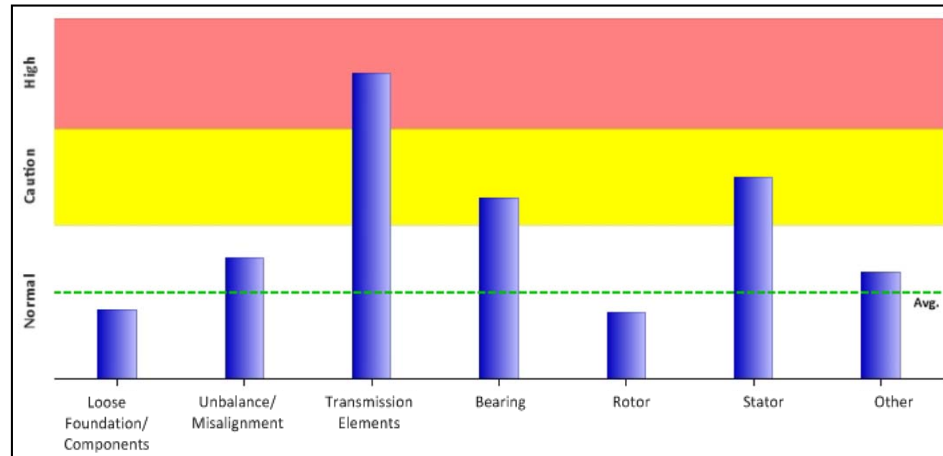
AMT test results indicate a fault in the transmission element. After a quick investigation in the transmission area, maintenance crew found that the belt was loose and was brushing against the housing.

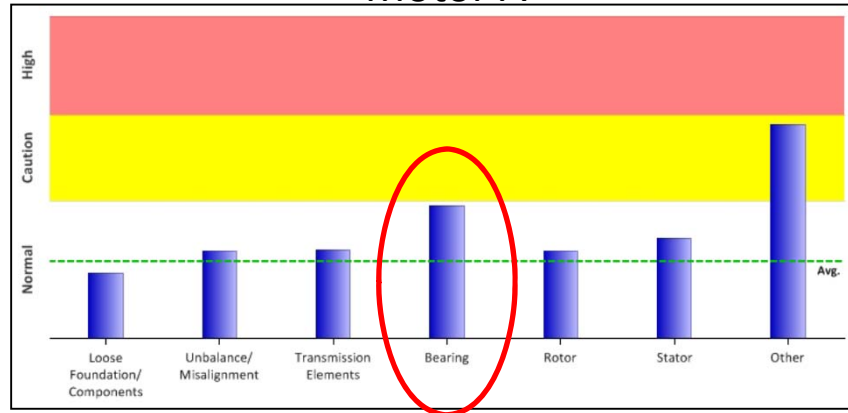
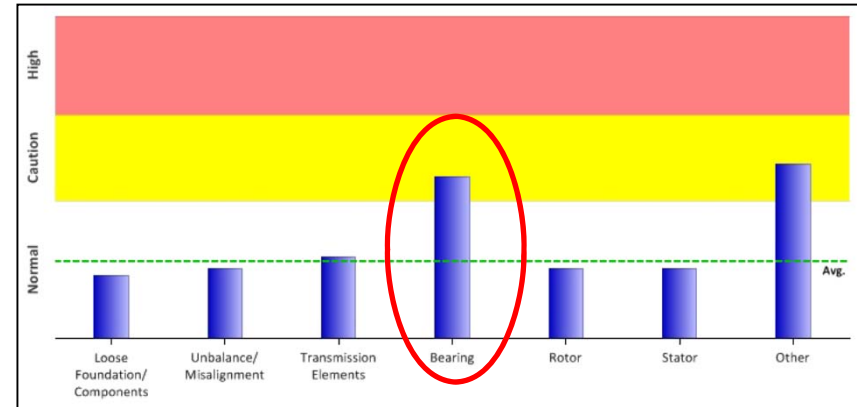
Even though these identical motors have been installed and been run altogether, AMT test results reveal that Motor B's bearing fault parameter is higher. Maintenance crew confirmed that Motor A's bearing house was replaced 9 months ago while Motor B was kept as it is. Motor B's bearing house will be replaced in the next scheduled maintenance.

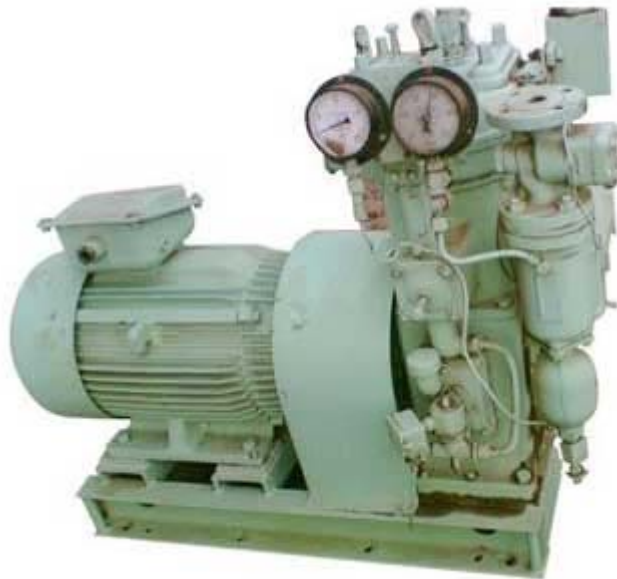
AMT test electrical parameter average results indicate that current unbalance parameter is substantially high. Maintenance expert in the firm has confirmed the finding of the report.

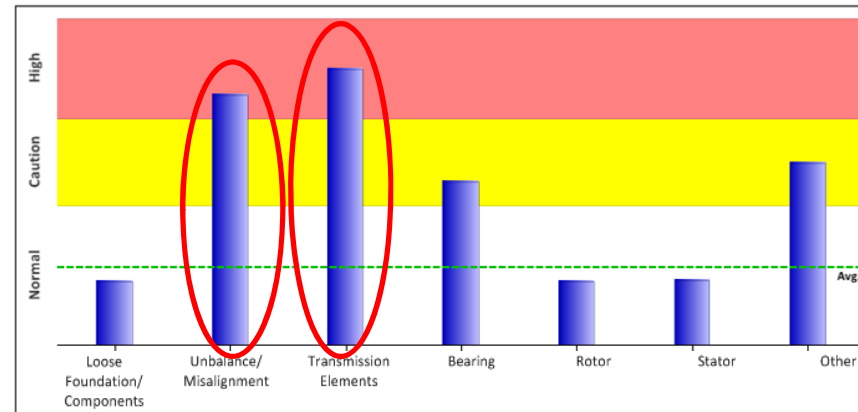
The report indicates transmission element and unbalance faults as well as a caution for bearing faults

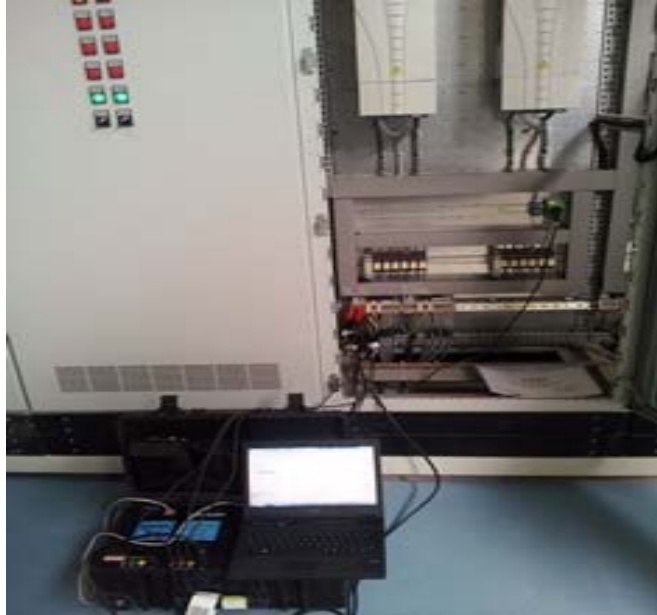
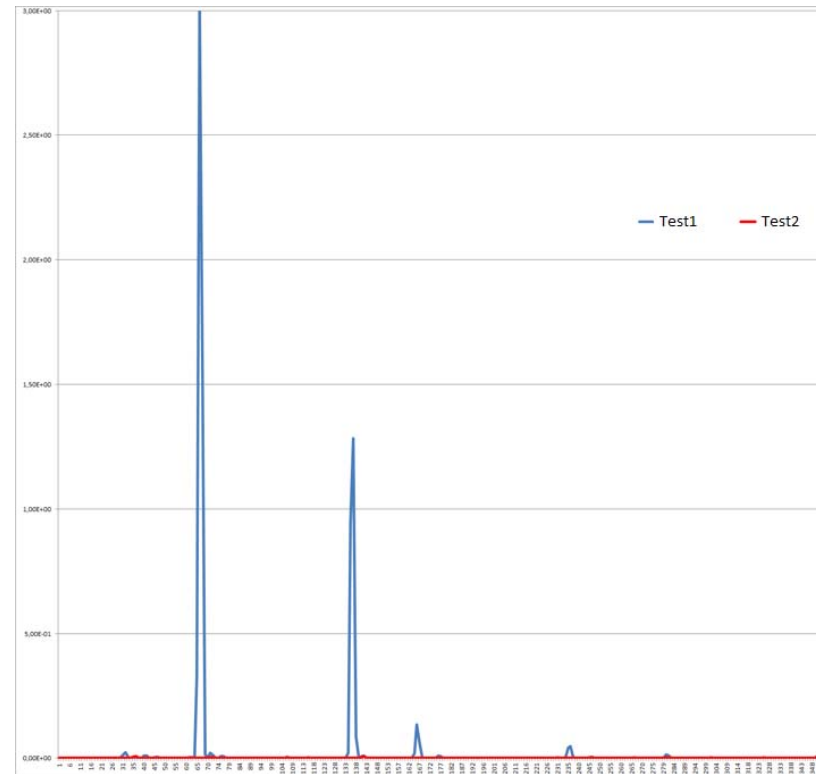
A second test was conducted after removing the transmission element. The second test indicated only the caution for bearing faults as expected.

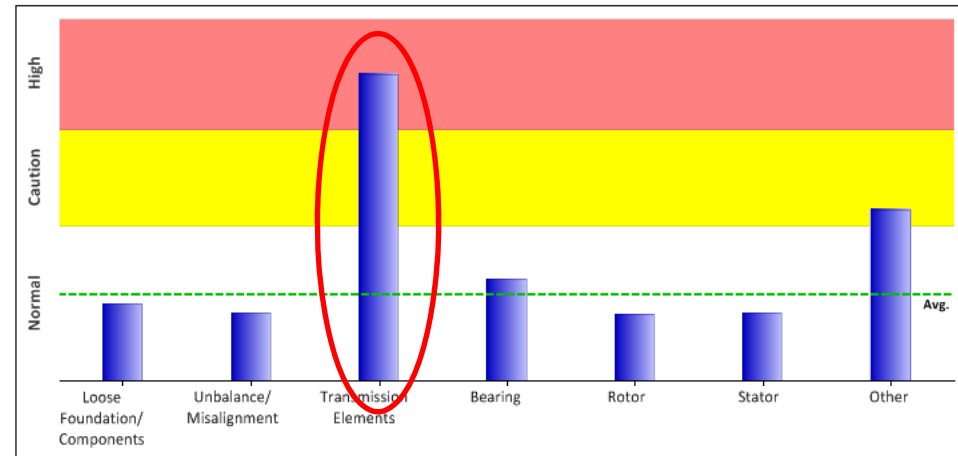
Fiber preparation machines are commonly used in the textile industry. AMT test of such a machine indicates the transmission element fault.

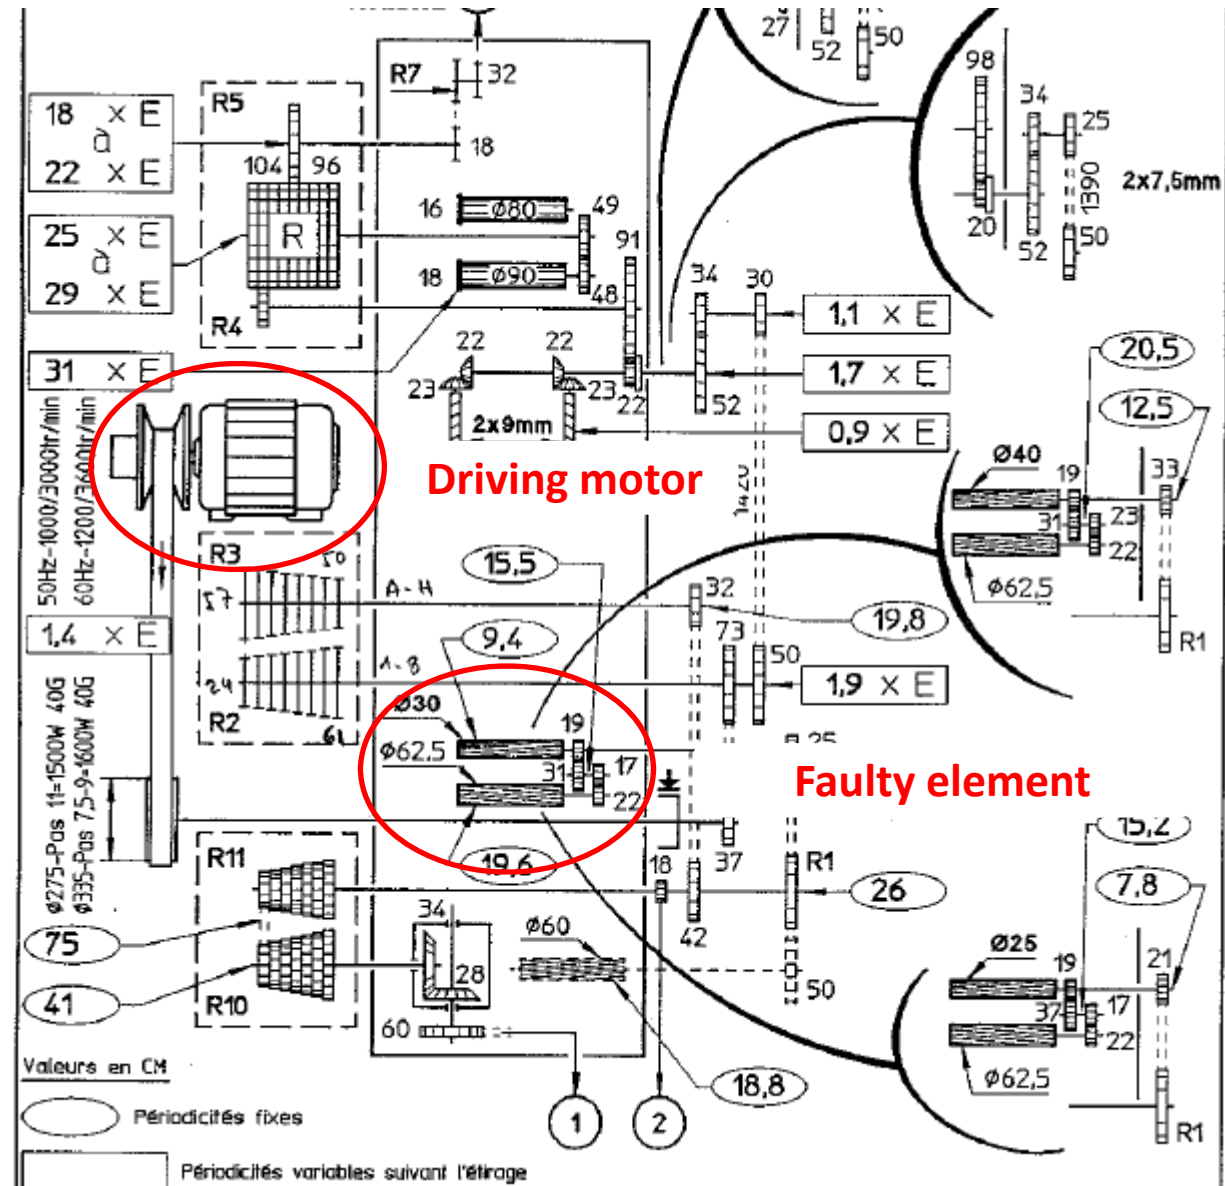
According to the kinetic diagram on the right, driving motor is providing mechanical power for the Fiber Preparation Equipment through several transmission elements. Artesis AMT detected the unbalance at the surface contacting fibers only through analyzing current and voltage signals.

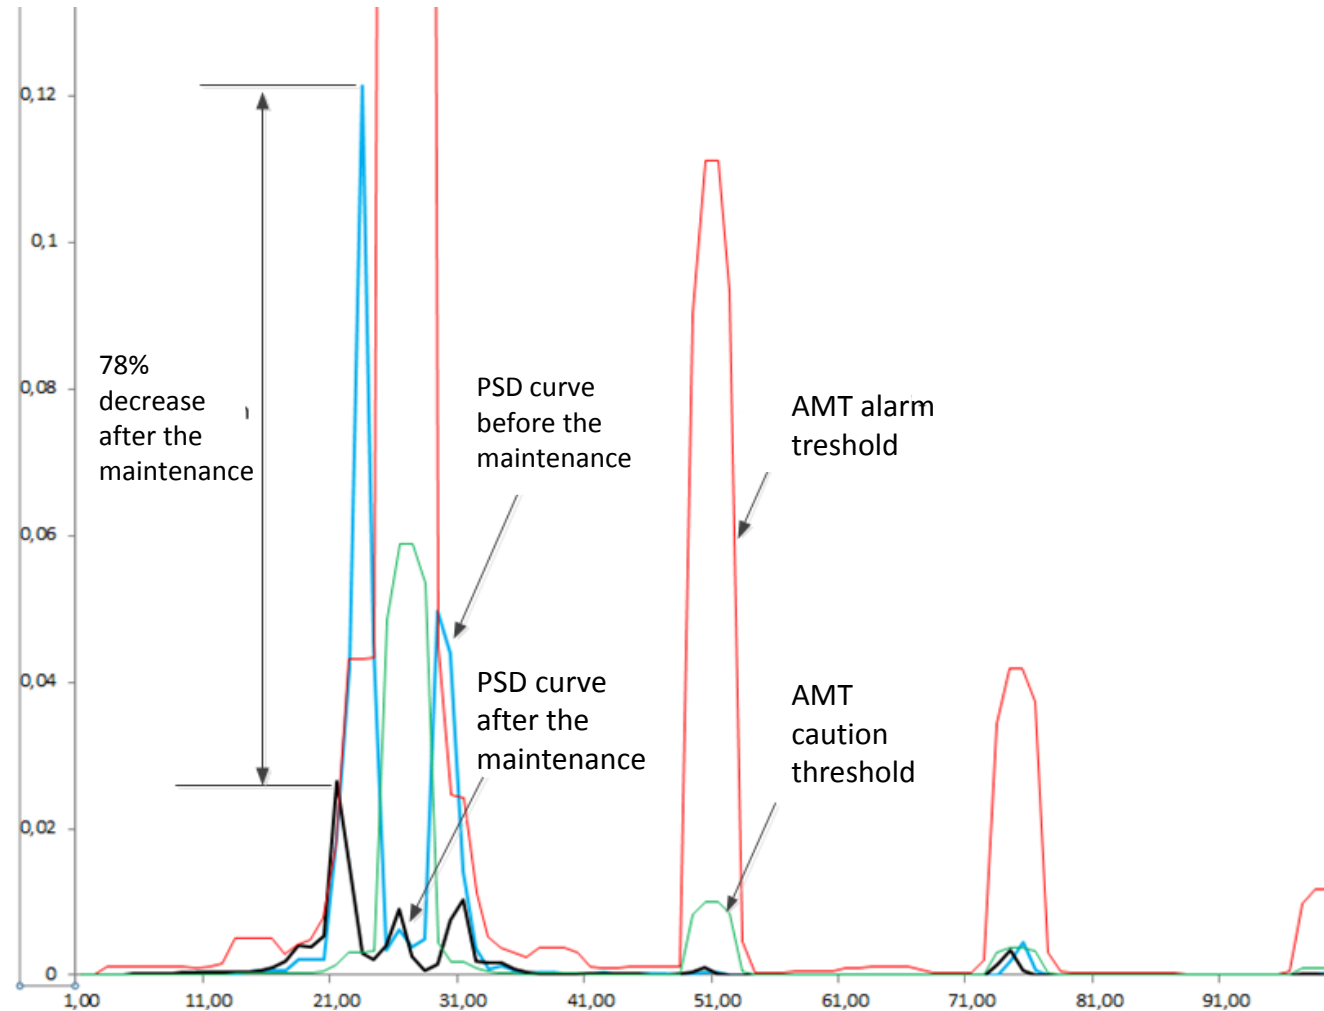
A second AMT test was conducted after a corrective maintenance action. Curves obtained before and after the maintenance are compared in the right figure. The comparison reveals that the maintenance action reduced the severity of fault 78% but not completely. This shows that AMT kit can also be used for evaluating the effectiveness of the maintenance action as well.

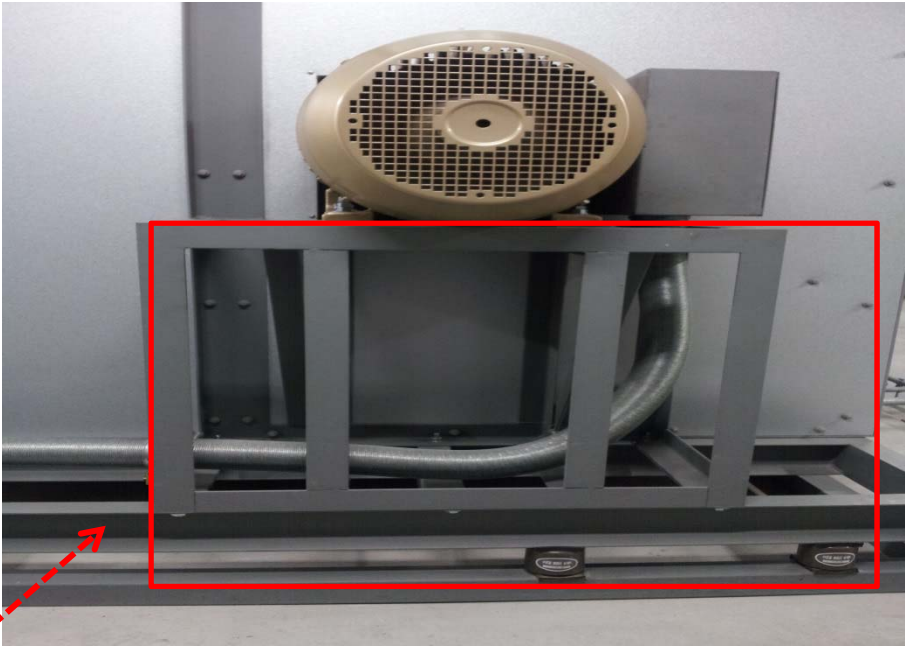
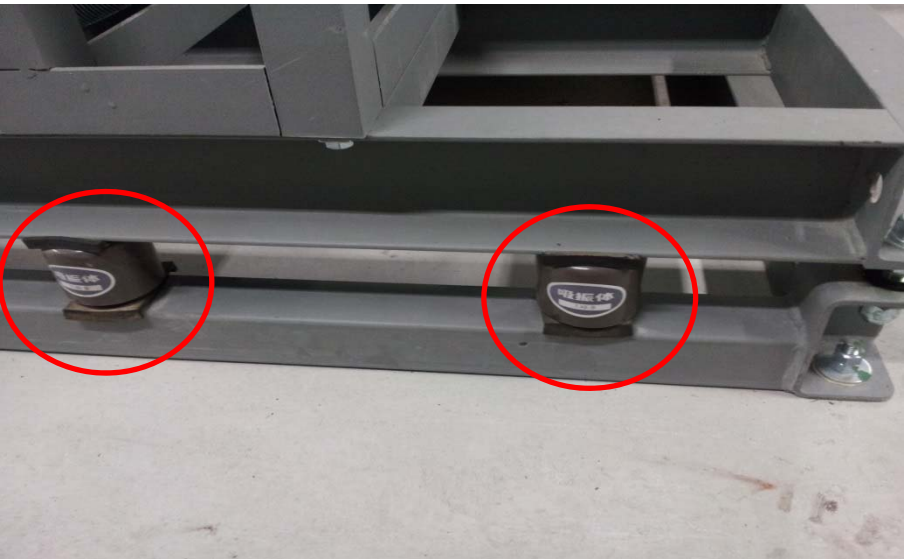
Two fan motors were tested using AMT. In one of the motors, loose foundation due to wrong mounting was detected.

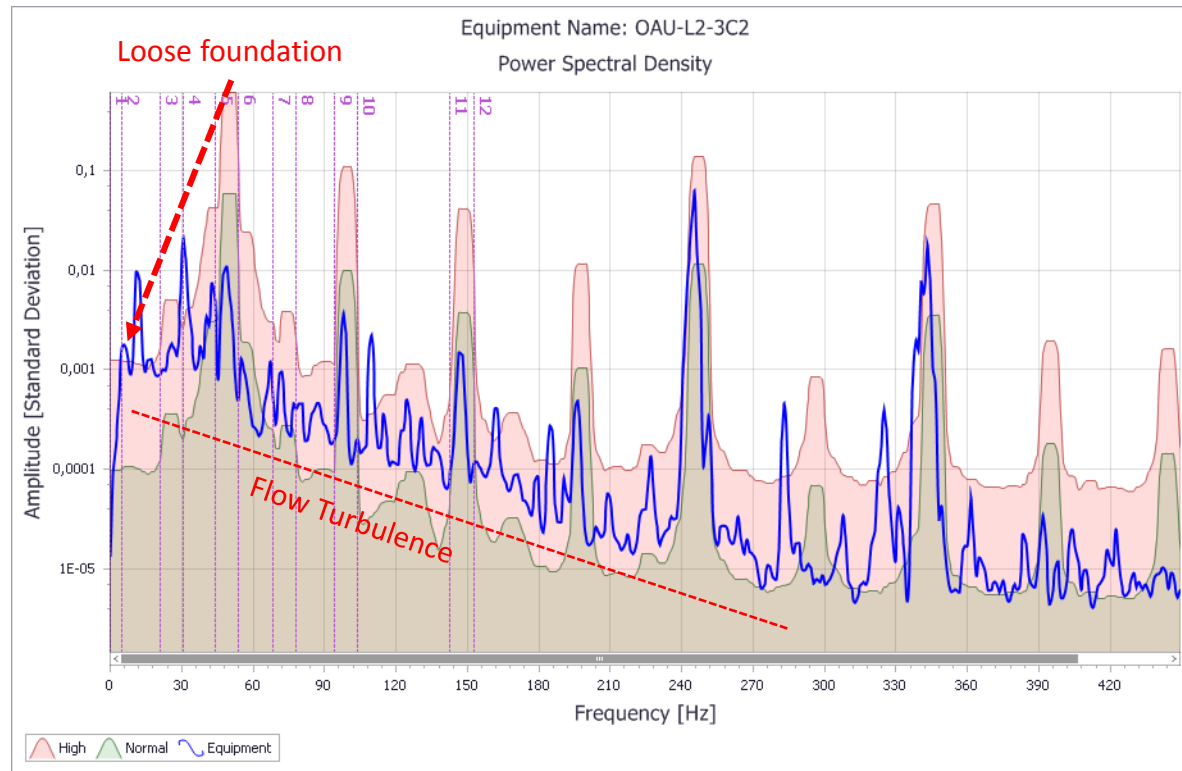
The loose foundation fault as shown above in the PSD plot was also confirmed by the maintenance crew.

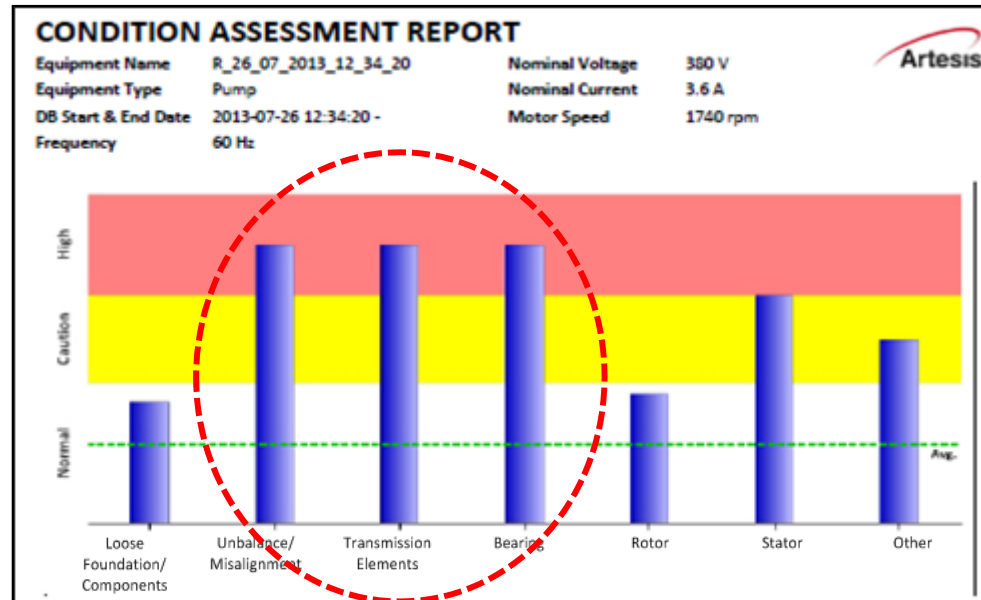
Artesis AMT analysis report clearly indicated faults in the transmission element, bearing and unbalance parameters, and relevant maintenance was planned accordingly.

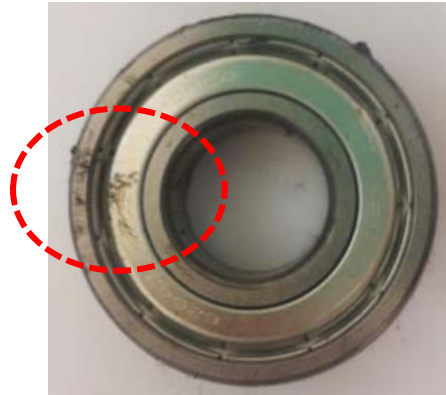
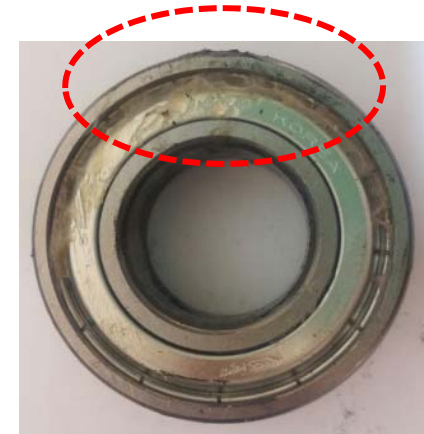
Maintenance team removed the bearings and observed damages in the internal parts of the bearings as well as oil leakage.

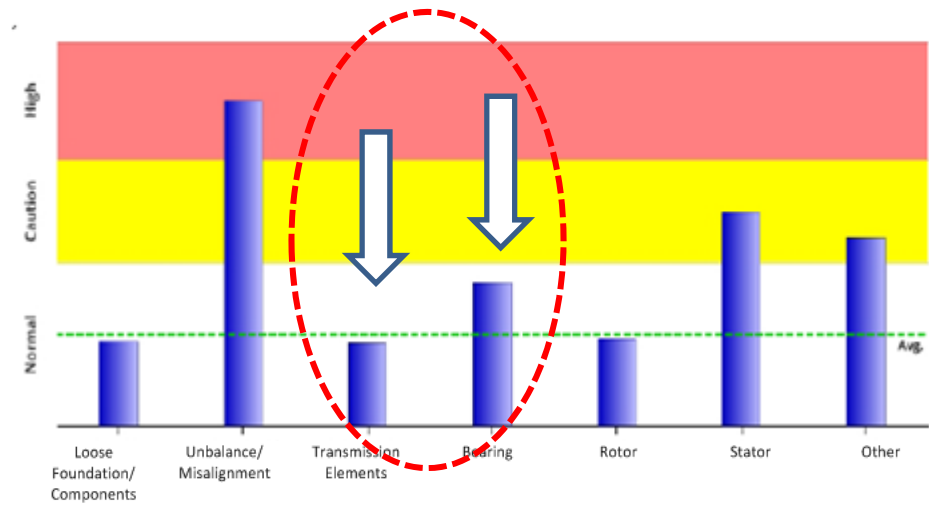
After the maintenance of bearing and transmission element, the equipment was tested again. The results indicated effectiveness of the corrective maintenance action for bearing and transmission element, while unbalance fault remained as it was.

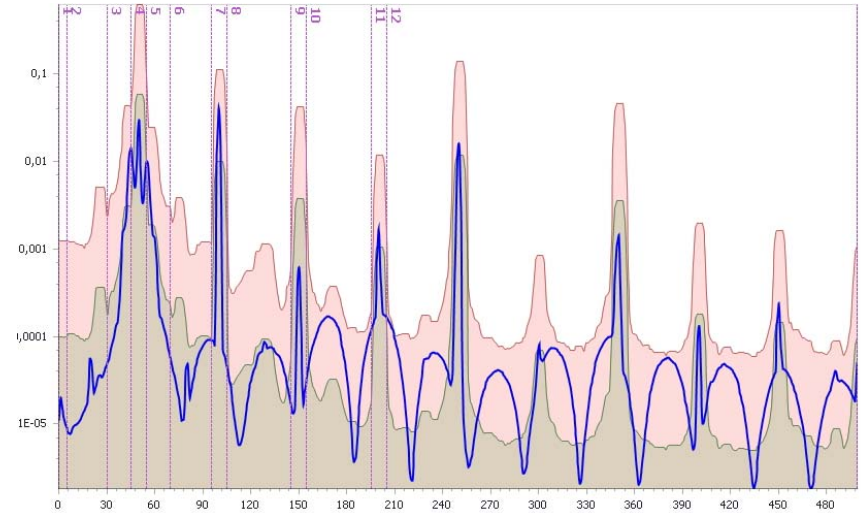
AMT power spectrum density (PSD) curve indicated a cavitation in the pump.

Cavitation fault was observed by the maintenance team verifying the diagnosis of AMT.

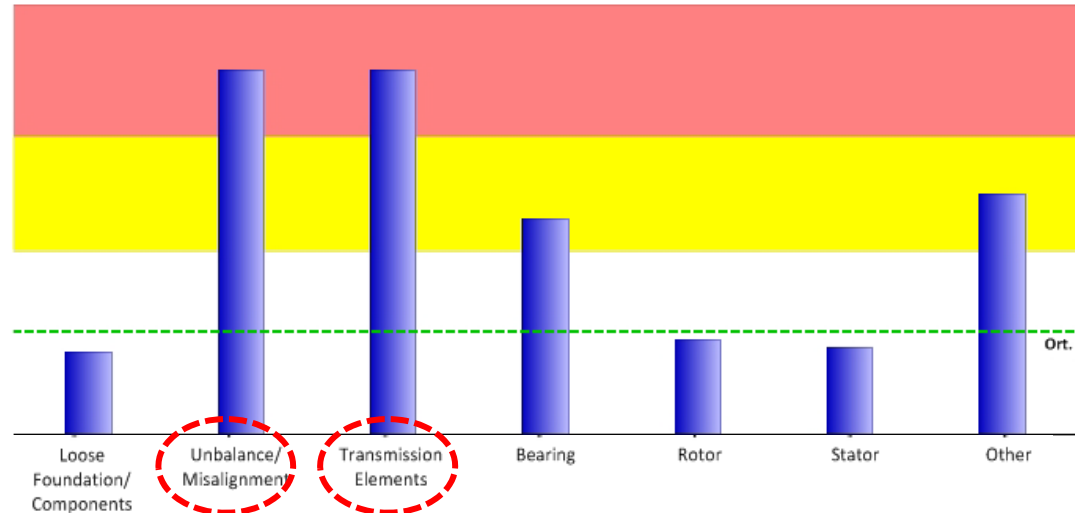
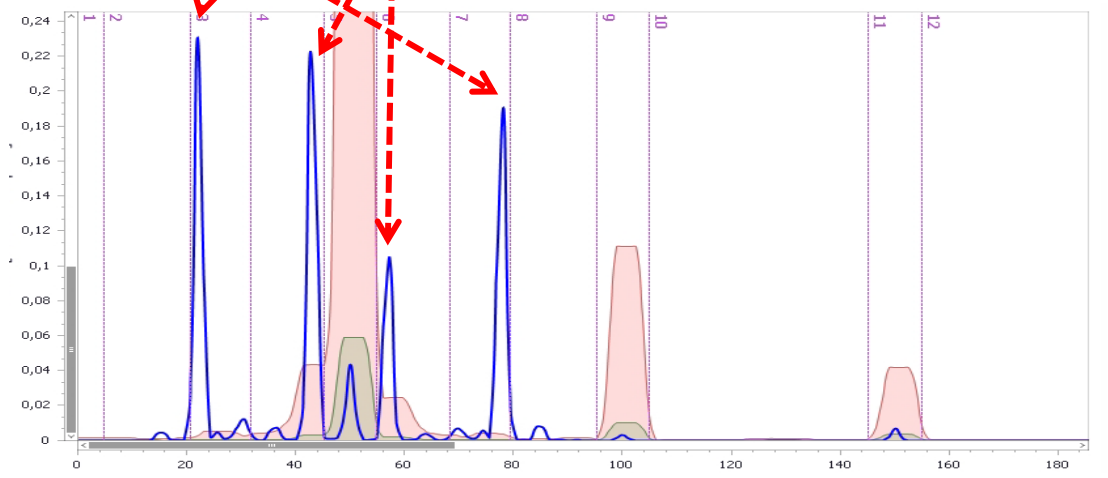
Artesis AMT analysis report reflected a fault alarm for the transmission element.

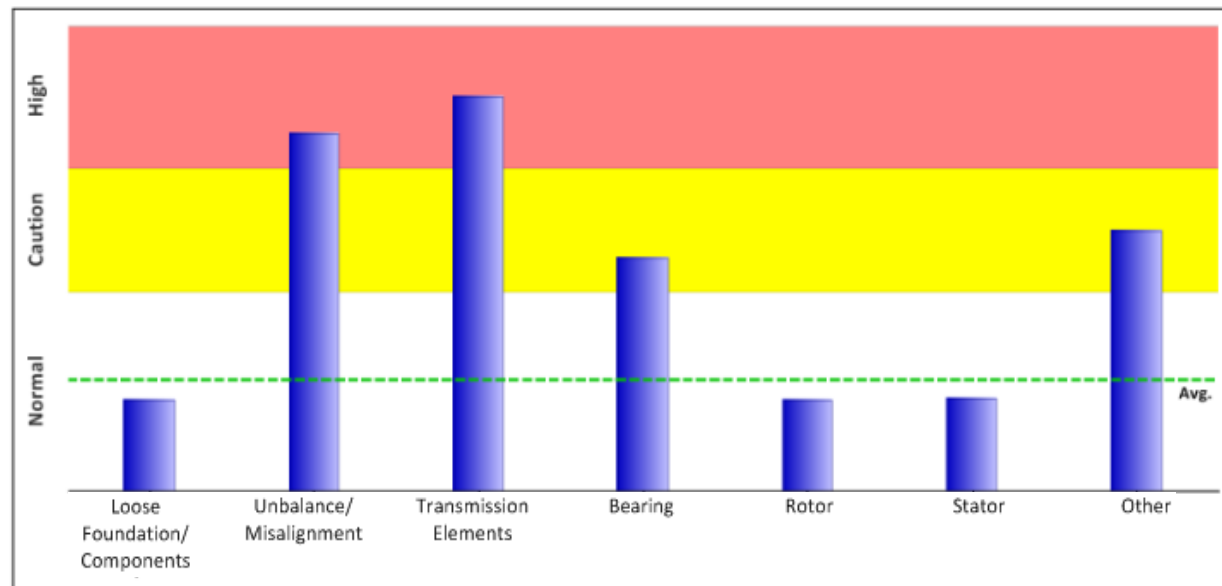
Kiln switch house fan in a metallurgy facility were analysed using AMT two times. First AMT results yielded to transmission element and unbalance faults and maintenance was planned accordingly.

Although the maintenance was conducted, and belts and balance wheels were fixed, second measurement still reflected problems for these parameters.

From the second AMT results it was determined that **maintenance should be repeated** and loose belt and unbalance problems should be fixed properly with the help of auxiliary devices.

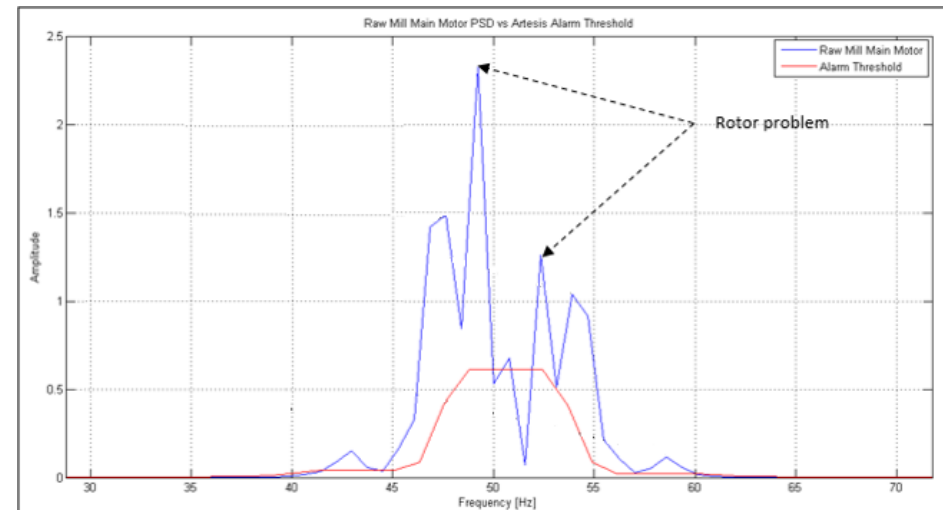
The PSD plot below shows peaks around supply frequency (51Hz). They indicate rotor fault as confirmed by the crew.

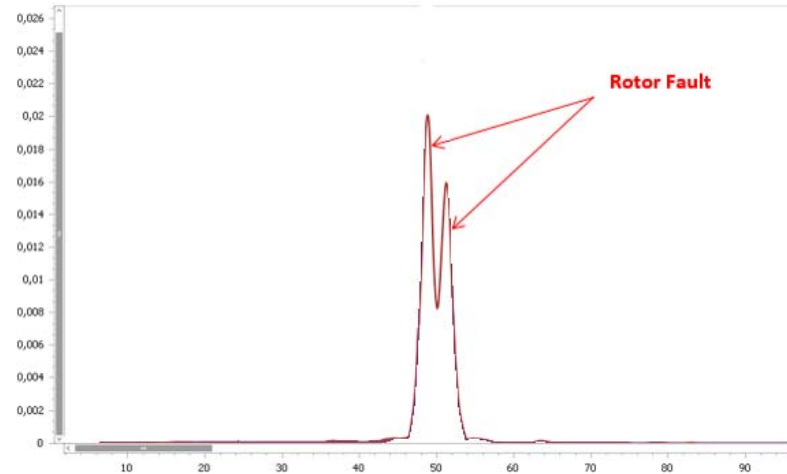
Boiler ID fan was suffered from a crack in the rotor bar according to the PSD curve and needed an immediate maintenance.

Two symmetrical peaks around  $50\text{Hz} \pm 1.2\text{ Hz}$  addressed to a crack or break in rotor bars or short circuit rings.

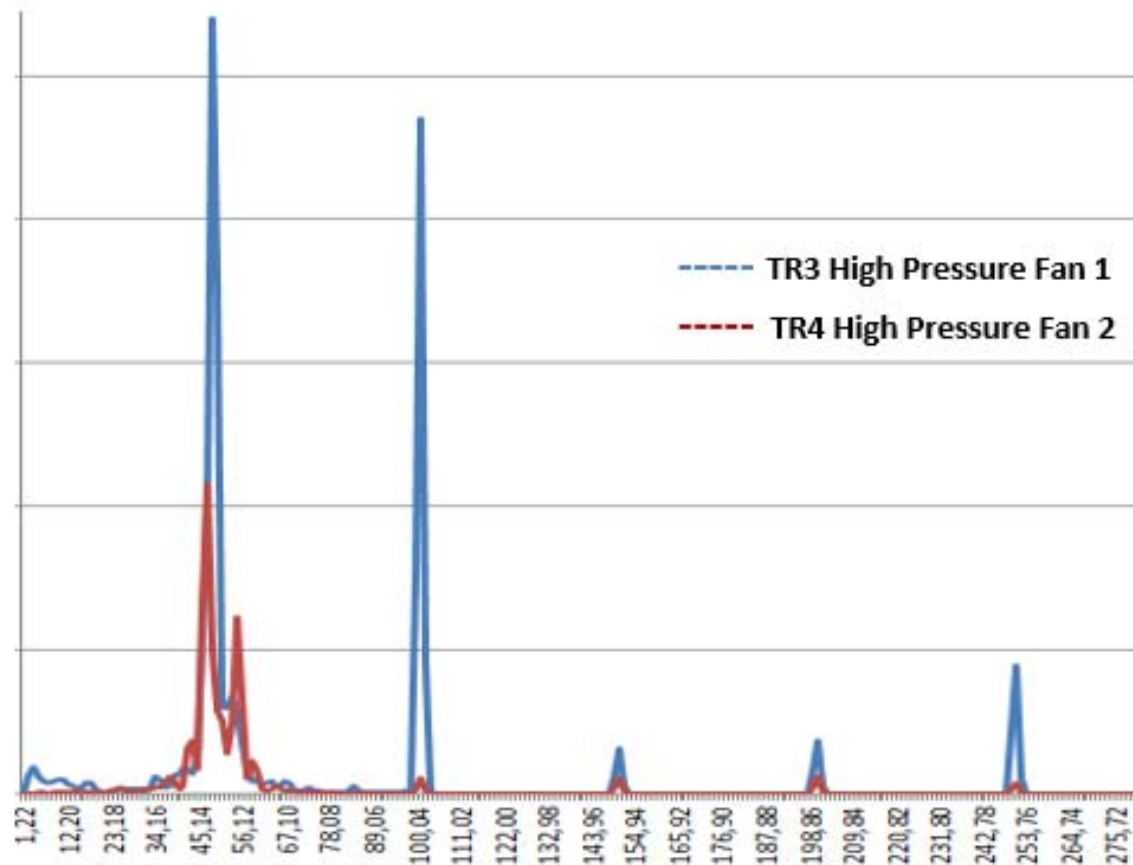
Comparison of two identical high pressure fans are observed in the PSD curve plot. There was a substantial difference between stator fault bands.

For Fan 1, maintenance action was required within 3 months.

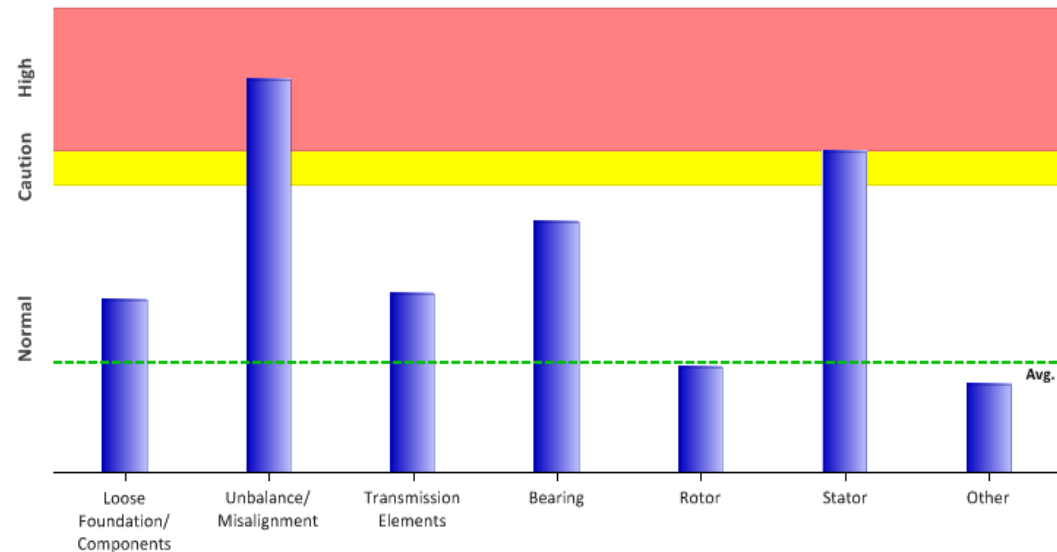
Rotary Kiln Fan in a chrome facility was suffering from faults such as unbalance and stator at serious levels; loose foundation, transmission element and bearing faults at moderate levels.

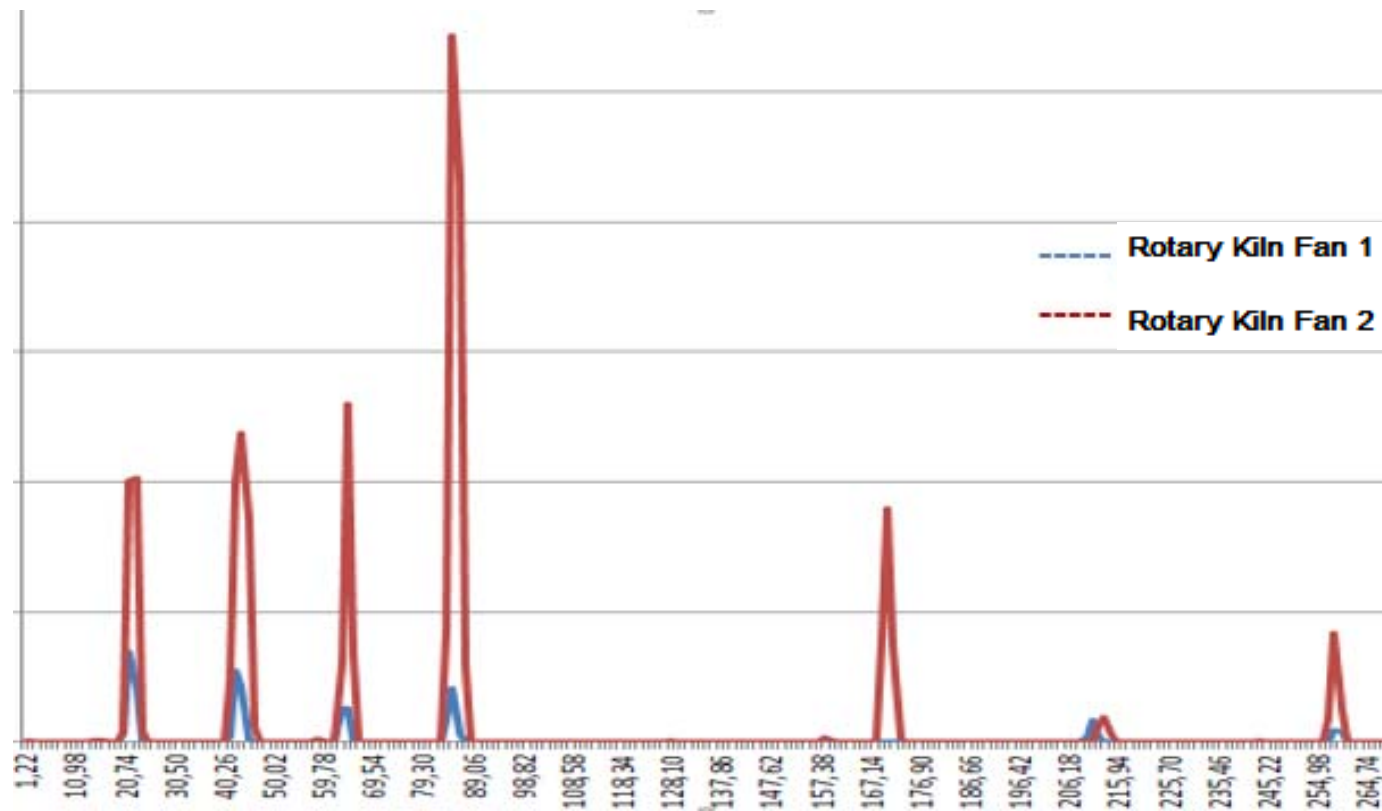
PSD curves of two identical Rotary Kiln Fans showed that unbalance, stator fault parameter and total harmonic distortion (5.6%) were much higher in Fan 2 compared to Fan 1. Fan 1 and Fan 2 was required a maintenance within 6 and 3 months respectively.

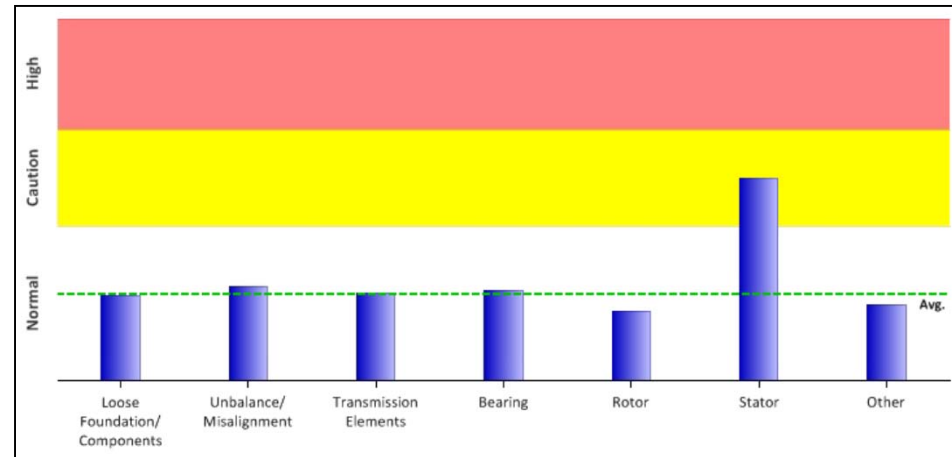
AMT test indicates a stator fault.

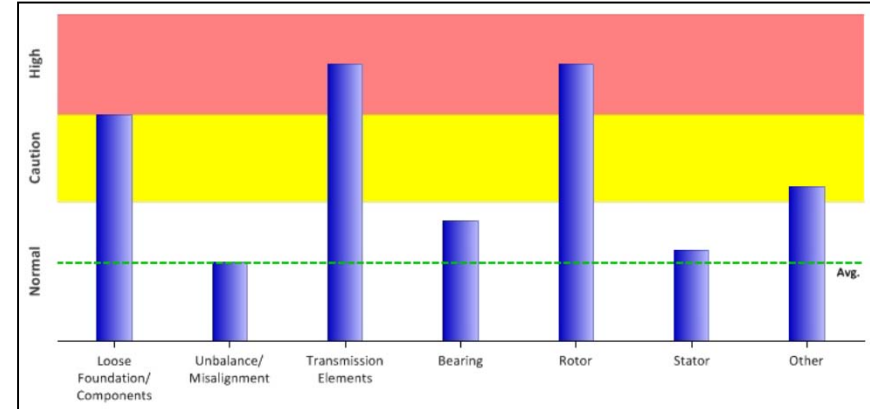
AMT test indicates transmission and rotor faults, as well as caution for loose foundation. Warnings for over current and high THD were issued as well.

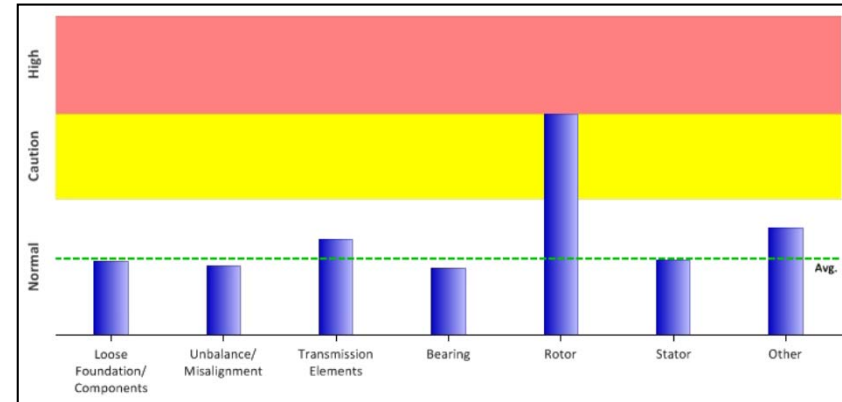
AMT test indicates a rotor fault.

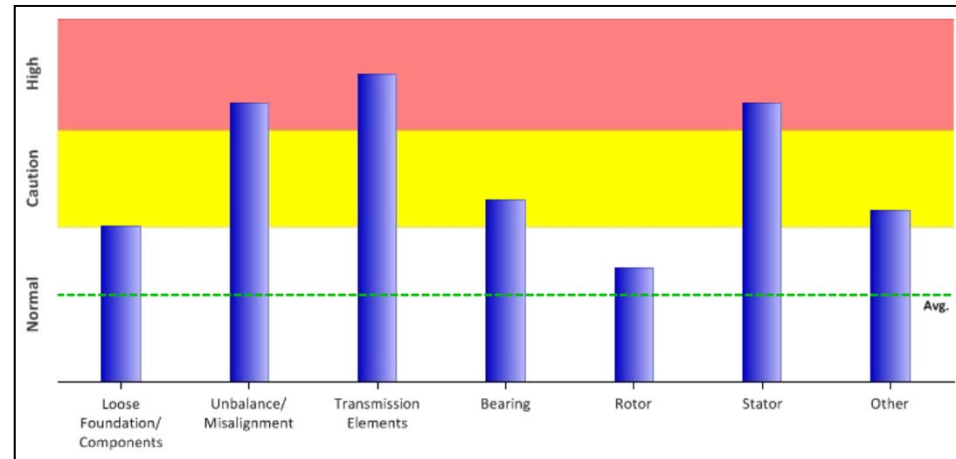
AMT test indicates unbalance, transmission and stator faults, as well as caution for bearing.

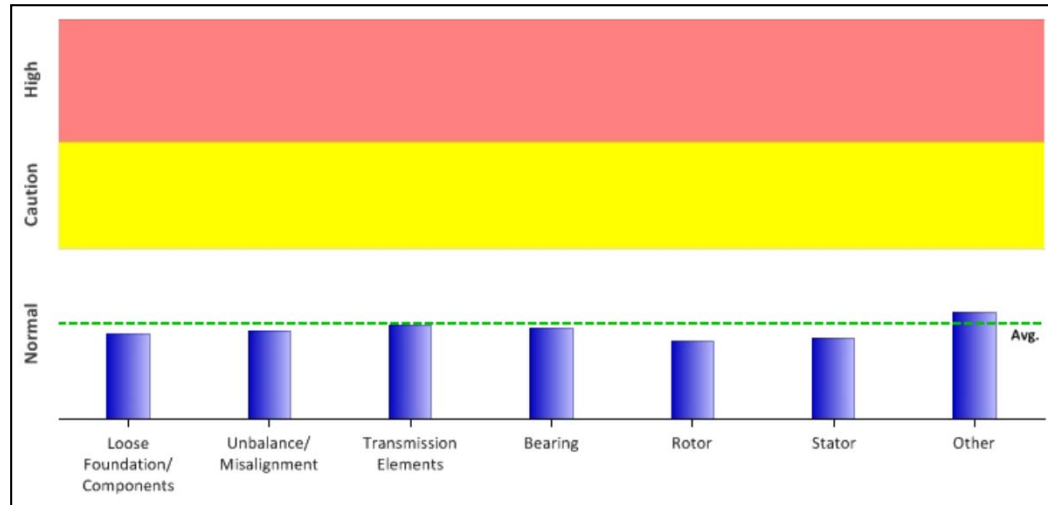
AMT test indicates the equipment was in good condition.
