# Artesis AMT

## Condition Assessment Cases

This document presents fault detection and diagnosis examples of AMT for various equipment in various industries. Examples of fault comparison between two identical equipment, before-after maintenance measurements and basic PSD curve analyses are given.

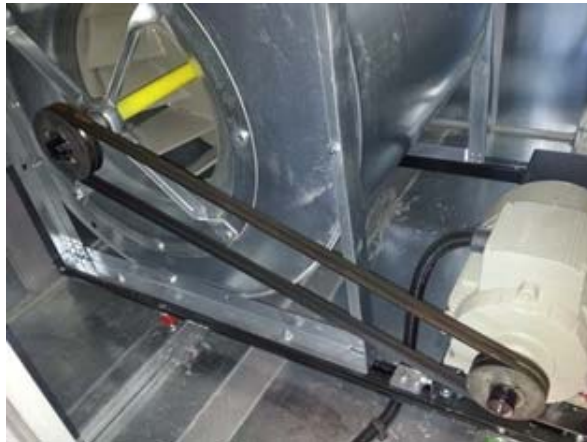
The report indicates transmission element and unbalance faults as well as a caution for bearing faults

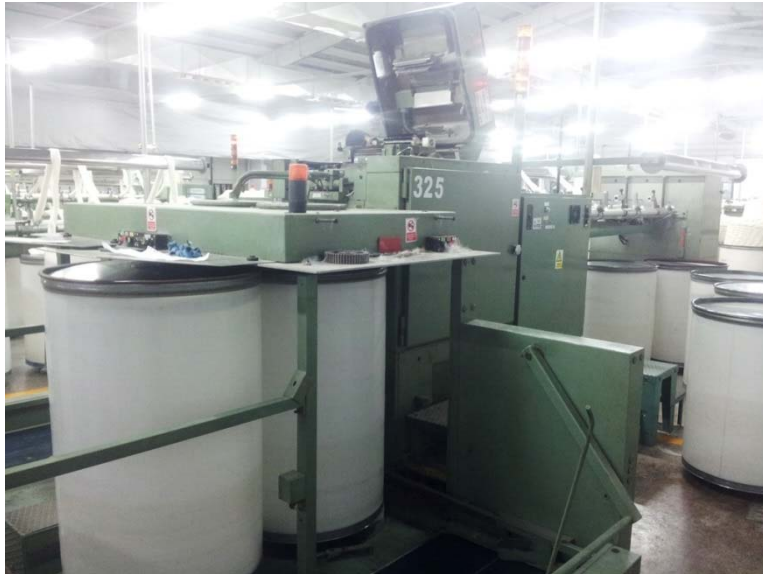
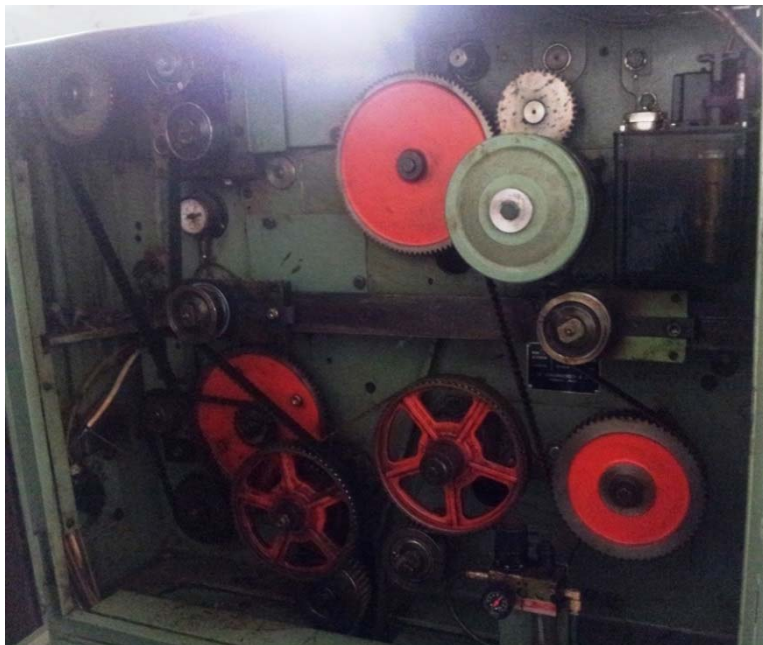
Fiber preparation machines are commonly used in the textile industry. AMT test of such a machine indicates the transmission element fault.

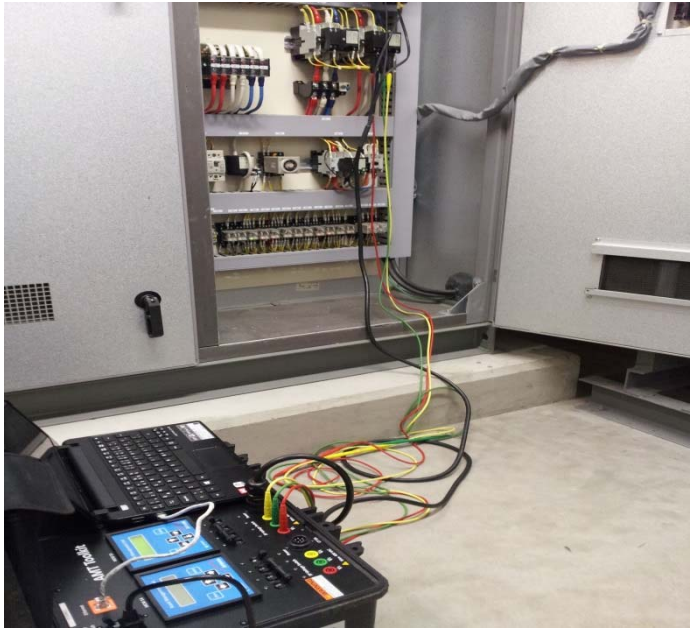
Two fan motors were tested using AMT. In one of the motors, loose foundation due to wrong mounting was detected.

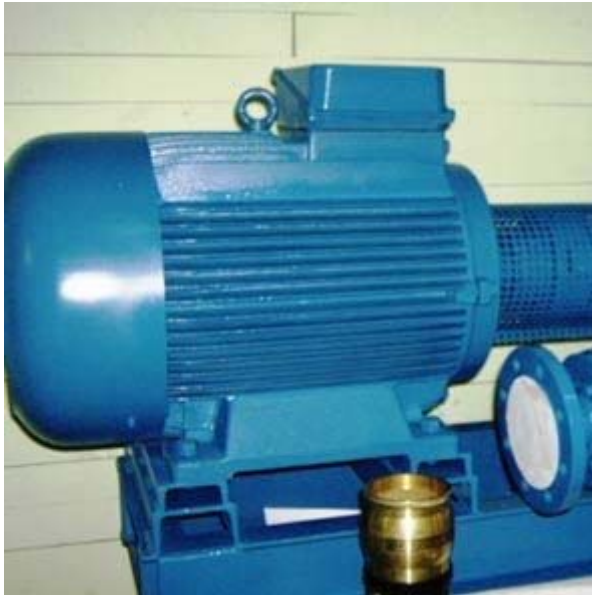
Artesis AMT analysis report clearly indicated faults in the transmission element, bearing and unbalance parameters, and relevant maintenance was planned accordingly.

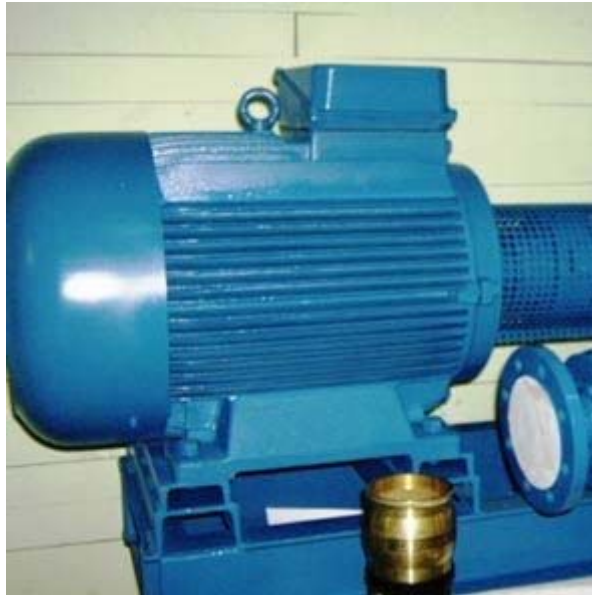
Maintenance team removed the bearings and observed damages in the internal parts of the bearings as well as oil leakage.

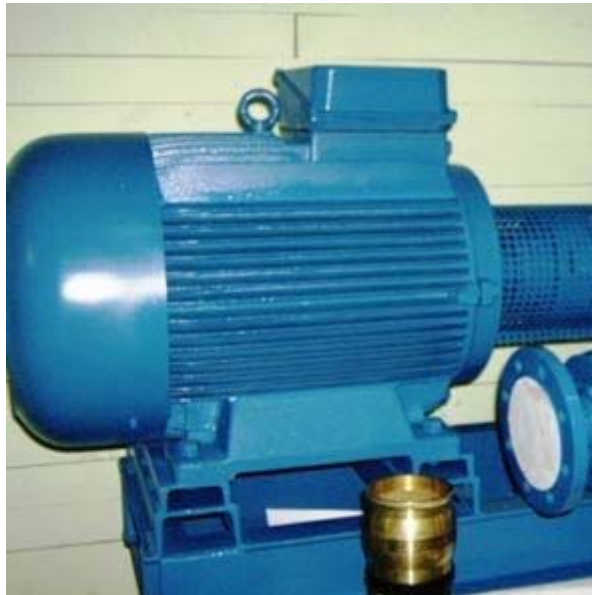
After the maintenance of bearing and transmission element, the equipment was tested again. The results indicated effectiveness of the corrective maintenance action for bearing and transmission element, while unbalance fault remained as it was.

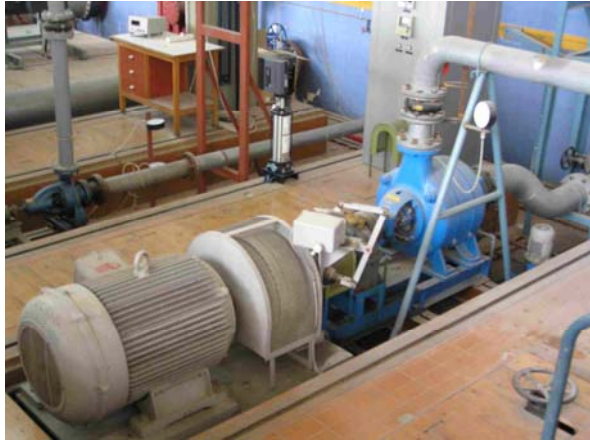
AMT power spectrum density (PSD) curve indicated a cavitation in the pump.

Cavitation fault was observed by the maintenance team verifying the diagnosis of AMT.

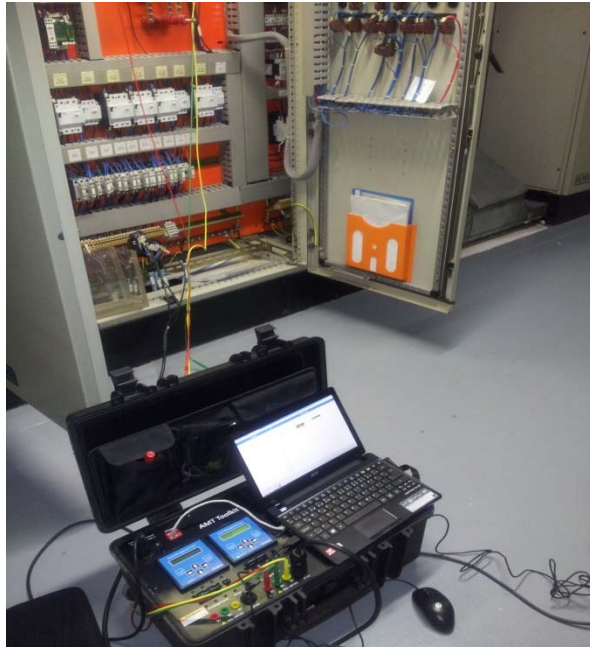
Artesis AMT analysis report reflected a fault alarm for the transmission element.

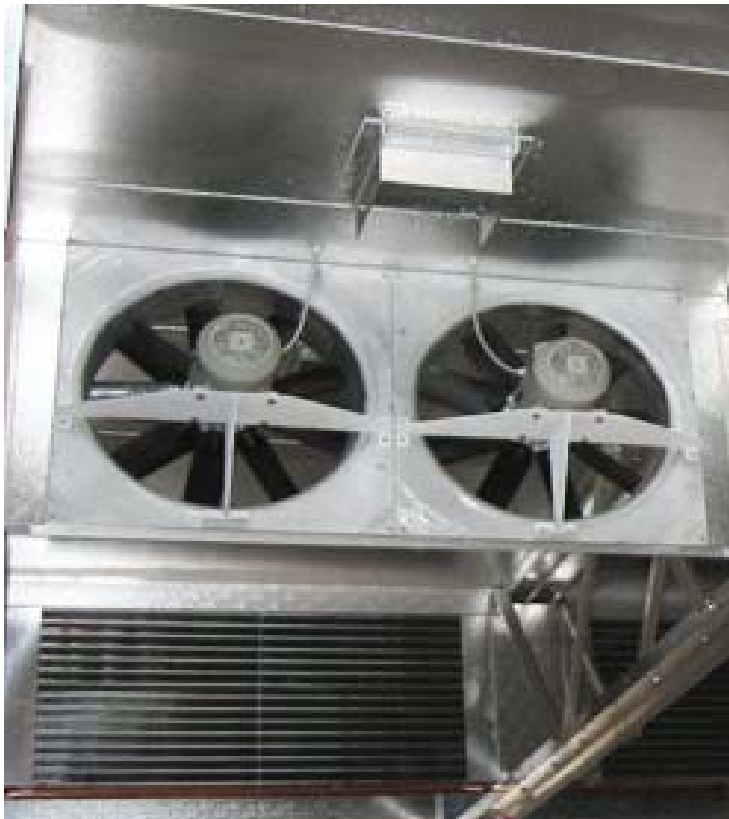
Kiln switch house fan in a metallurgy facility were analysed using AMT two times. First AMT results yielded to transmission element and unbalance faults and maintenance was planned accordingly.

Although the maintenance was conducted, and belts and balance wheels were fixed, second measurement still reflected problems for these parameters.

From the second AMT results it was determined that **maintenance should be repeated** and loose belt and unbalance problems should be fixed properly with the help of auxiliary devices.

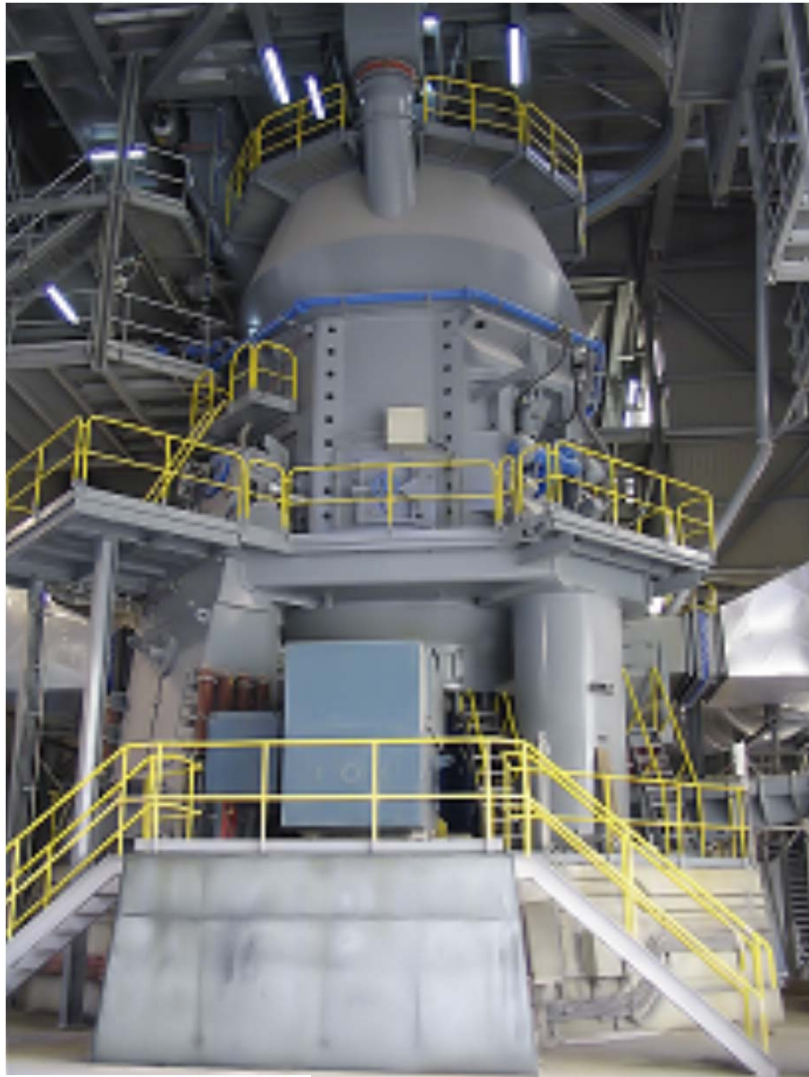
The PSD plot below shows peaks around supply frequency (51Hz). They indicate rotor fault as confirmed by the crew.

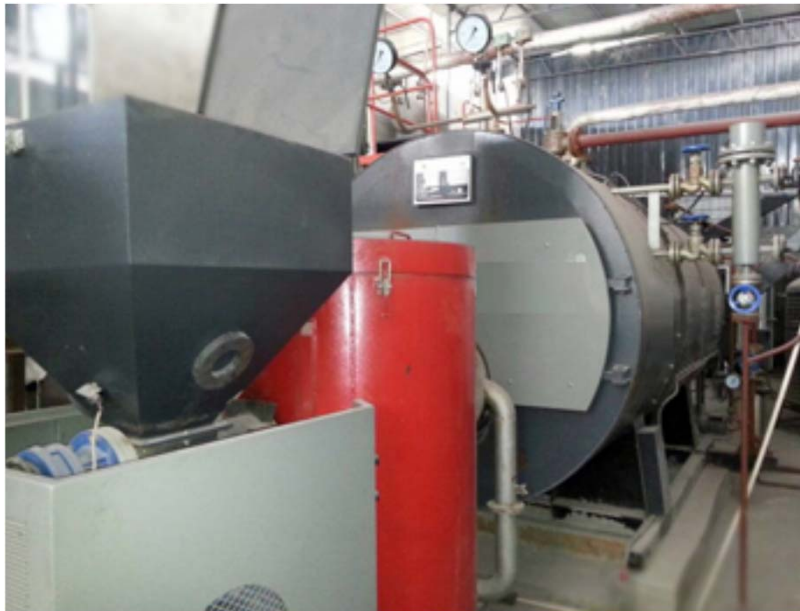
Boiler ID fan was suffered from a crack in the rotor bar according to the PSD curve and needed an immediate maintenance.

Two symmetrical peaks around  $50\text{Hz} \pm 1.2\text{ Hz}$  addressed to a crack or break in rotor bars or short circuit rings.

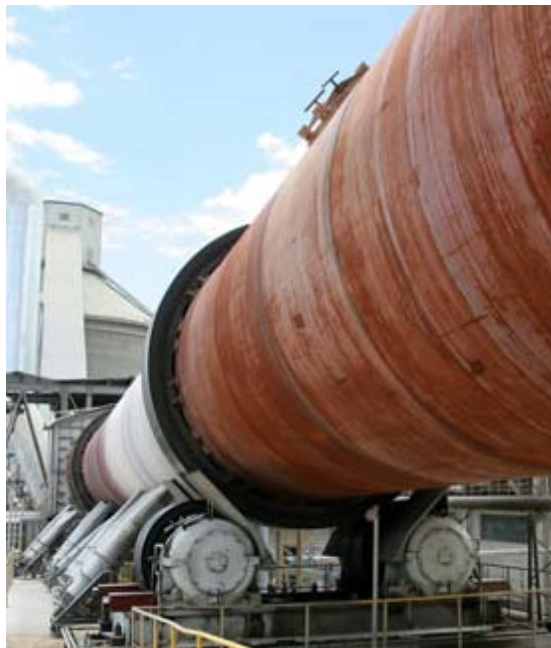
Rotary Kiln Fan in a chrome facility was suffering from faults such as unbalance and stator at serious levels; loose foundation, transmission element and bearing faults at moderate levels.
